Greenforest Incorporated

Consulting Arborist

February 10, 2016

RE: Amended Arborist Report for Orler Project, 12703 72nd Ave NE 98034

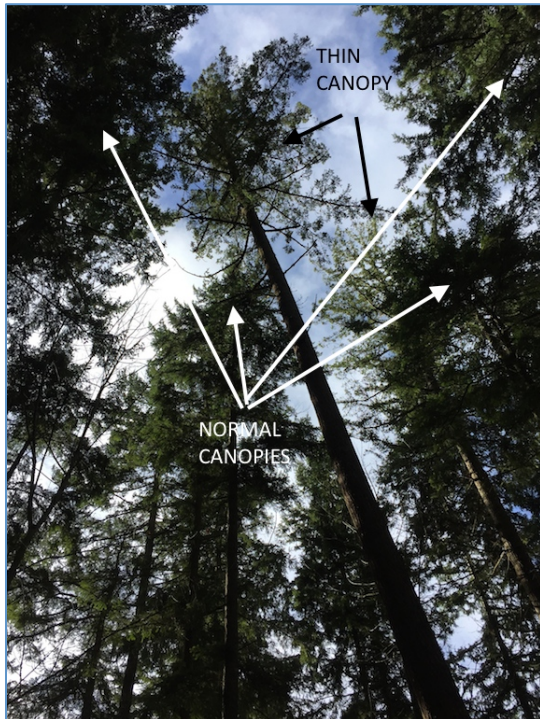
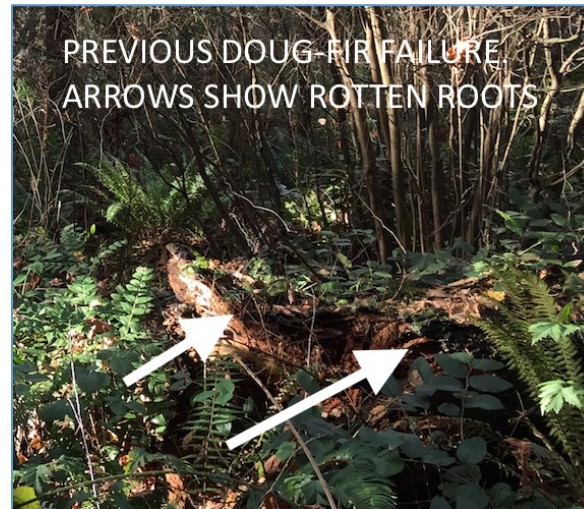
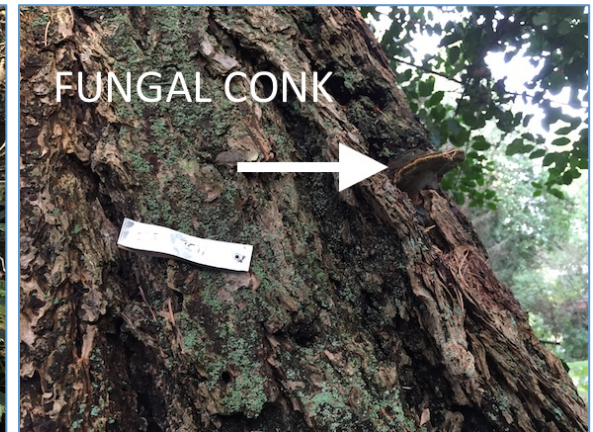
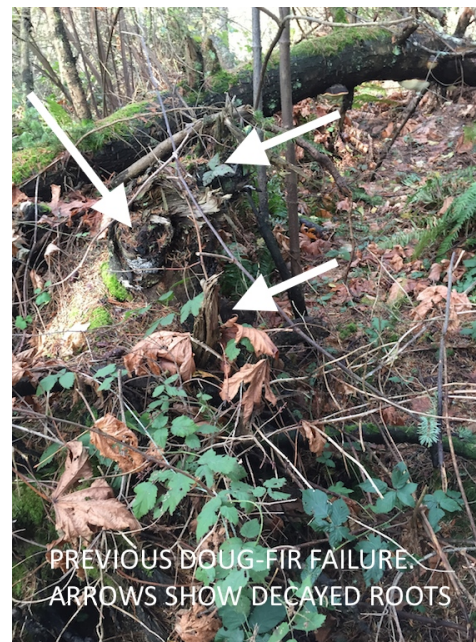
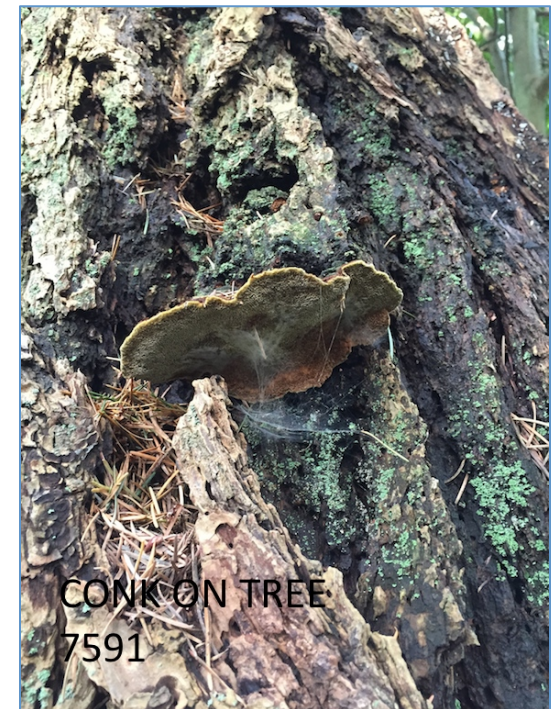
Attachment No. 6 – Disease Center
Images (Showing fungal conks, previous
windthrow and thin canopies.)

During my fieldwork, I observed signs and symptoms of a root rot pathogen within this third, south grove, including trees with fungal conks on trunks, thinning and chlorotic foliage, low shoot vigor, and previously windthrown trees with decayed structural roots. All the affected trees are Douglas-firs, and include 7589, 7590, 7591, 7598, 7599, 7605, 7606, 7607, and A. (See Attachment 6.)

DISEASE CENTER
FIR TREES WITH THINNING CANOPIES
FUNGAL CONKS
PREVIOUS WINDTHROWN TREES
(INSIDE DASHED LINE)
